**October 1998**

**TB 1620**

### **Those Mysterious Hot Spots**

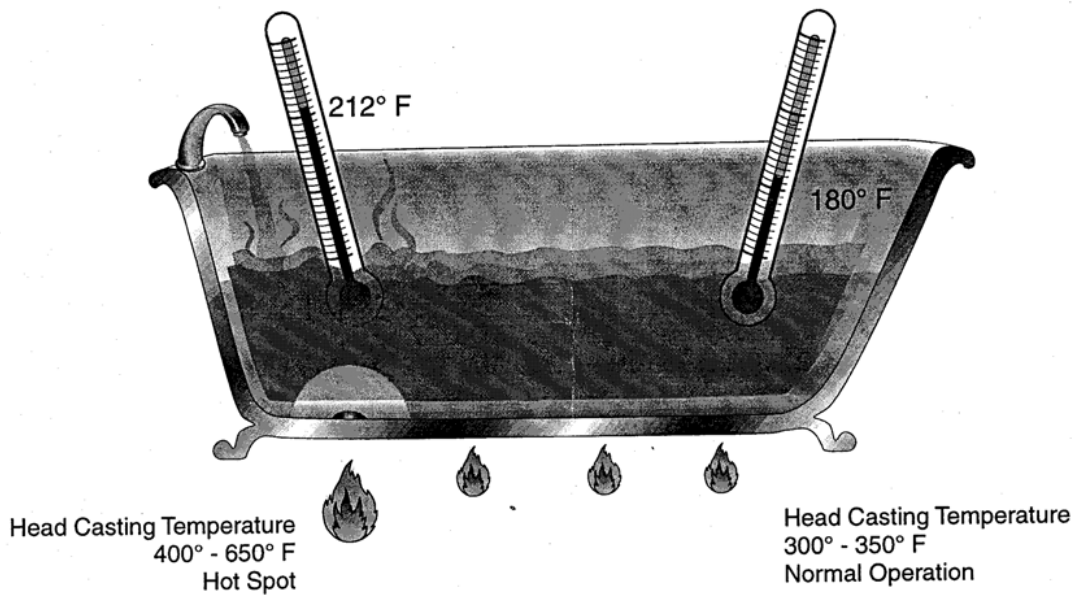
In the illustration shown below, consider the tub similar to a four cylinder head with four heat sources. The area above the drain inside the bathtub is a hot air bubble created from a boiling effect. The head temperature at the head gasket surface of 400 to 650° F cannot be adequately removed because of these air pockets. The tub or head casting has no choice but to expand excessively from the higher than normal operating temperatures. Understanding how the damage occurs is only the first step, while repairing what caused the damage is the ultimate goal.

The tub shown in the illustration above shows four flames under it as a heat source, similar to a cylinder head with four exhaust valves. Looking at the tub you will notice one of the flames appears hotter than the others. Relate that to a cylinder head with one exhaust valve operating hotter than the others for yet unknown reasons. Imagine that overheated area of the coolant boiling, creating hot air pockets. Those voids prevent engine coolant from remaining in contact with the casting to cool the hot spots, thus, losing control of cylinder head expansion at that particular location.
