Glass Surface Staining

GG 001—2015-02-24

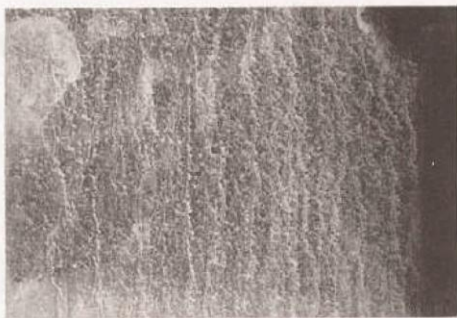
Figure 3 – Reaction Contaminant
Acid rain/masonry/glazing material
run-down on the glass surface.
Removal requires an acidic solution, or
may not be practically possible.

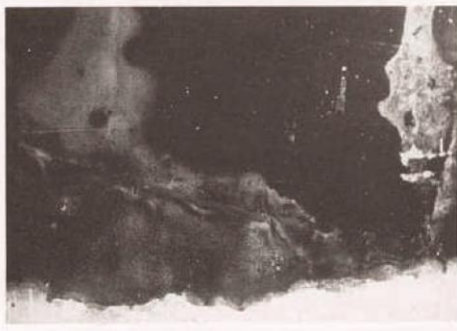
Figure 4 – Surface Corrosion
Glass corrosion is typically caused by
prolonged exposure to high humidity
and temperature and is often not
removable.
